# PROJECT REPRESENTATIVE'S DAILY REPORT

Pg. 1  
Report No. 111  
Date: 2015-01-29  
Day: Thursday

**Project:** Renovation and Addition to Tewksbury Town Hall

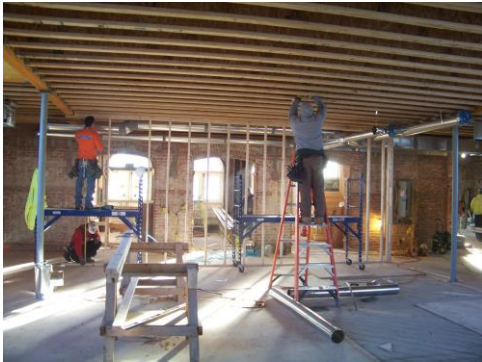
Photo showing a tin knocker (foreground) installing ductwork, and a carpenter installing framing for wall.

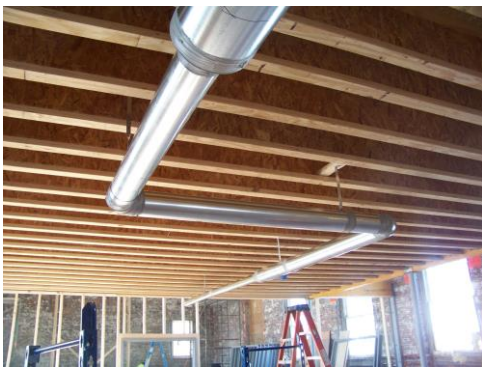
Photo showing ductwork in place for the 1<sup>st</sup> floor.

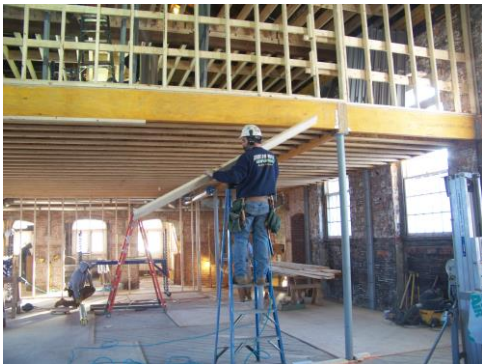
Photo showing carpenter installing framing for east wall of the meeting hall.

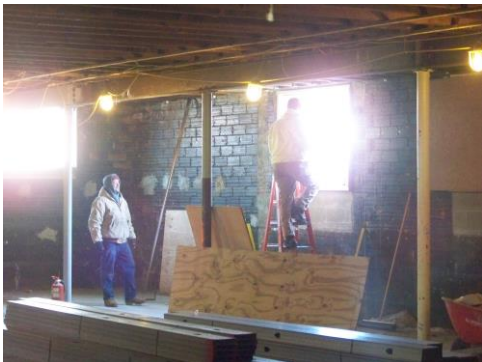
Photo showing carpenters installing blocking for the basement windows.

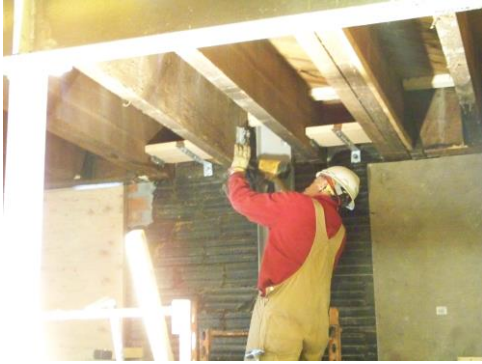
Photo showing carpenter installing joists hangers at post locations.

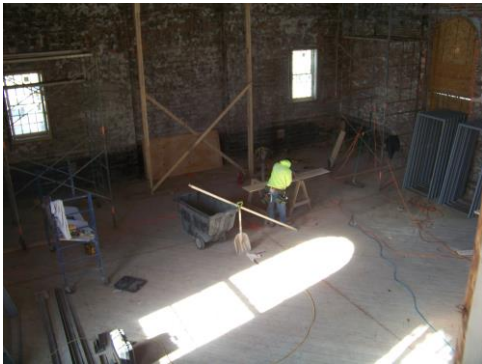
Photo showing carpenter laying out the location for the platform at the west end of the meeting hall.
